**SITE ASSESSMENT REPORT  
WILSON SHIRT FACTORY REMOVAL ASSESSMENT  
SOUTH BEND, INDIANA**

**U.S. ENVIRONMENTAL PROTECTION AGENCY  
Region 5  
Chicago, Illinois 60604**

<b>TDD NO.:</b>	S05-0001-1903-300	
<b>EPA OSC:</b>	Thomas Mendez	
<b>SITE NAME:</b>	Wilson Shirt Factory – RS	
<b>SITE LOCATION:</b>	South Bend, St. Joseph County, Indiana	
<b>REPORT PREPARER:</b>	Brendan Martin	
<b>SIGNATURE/DATE</b>

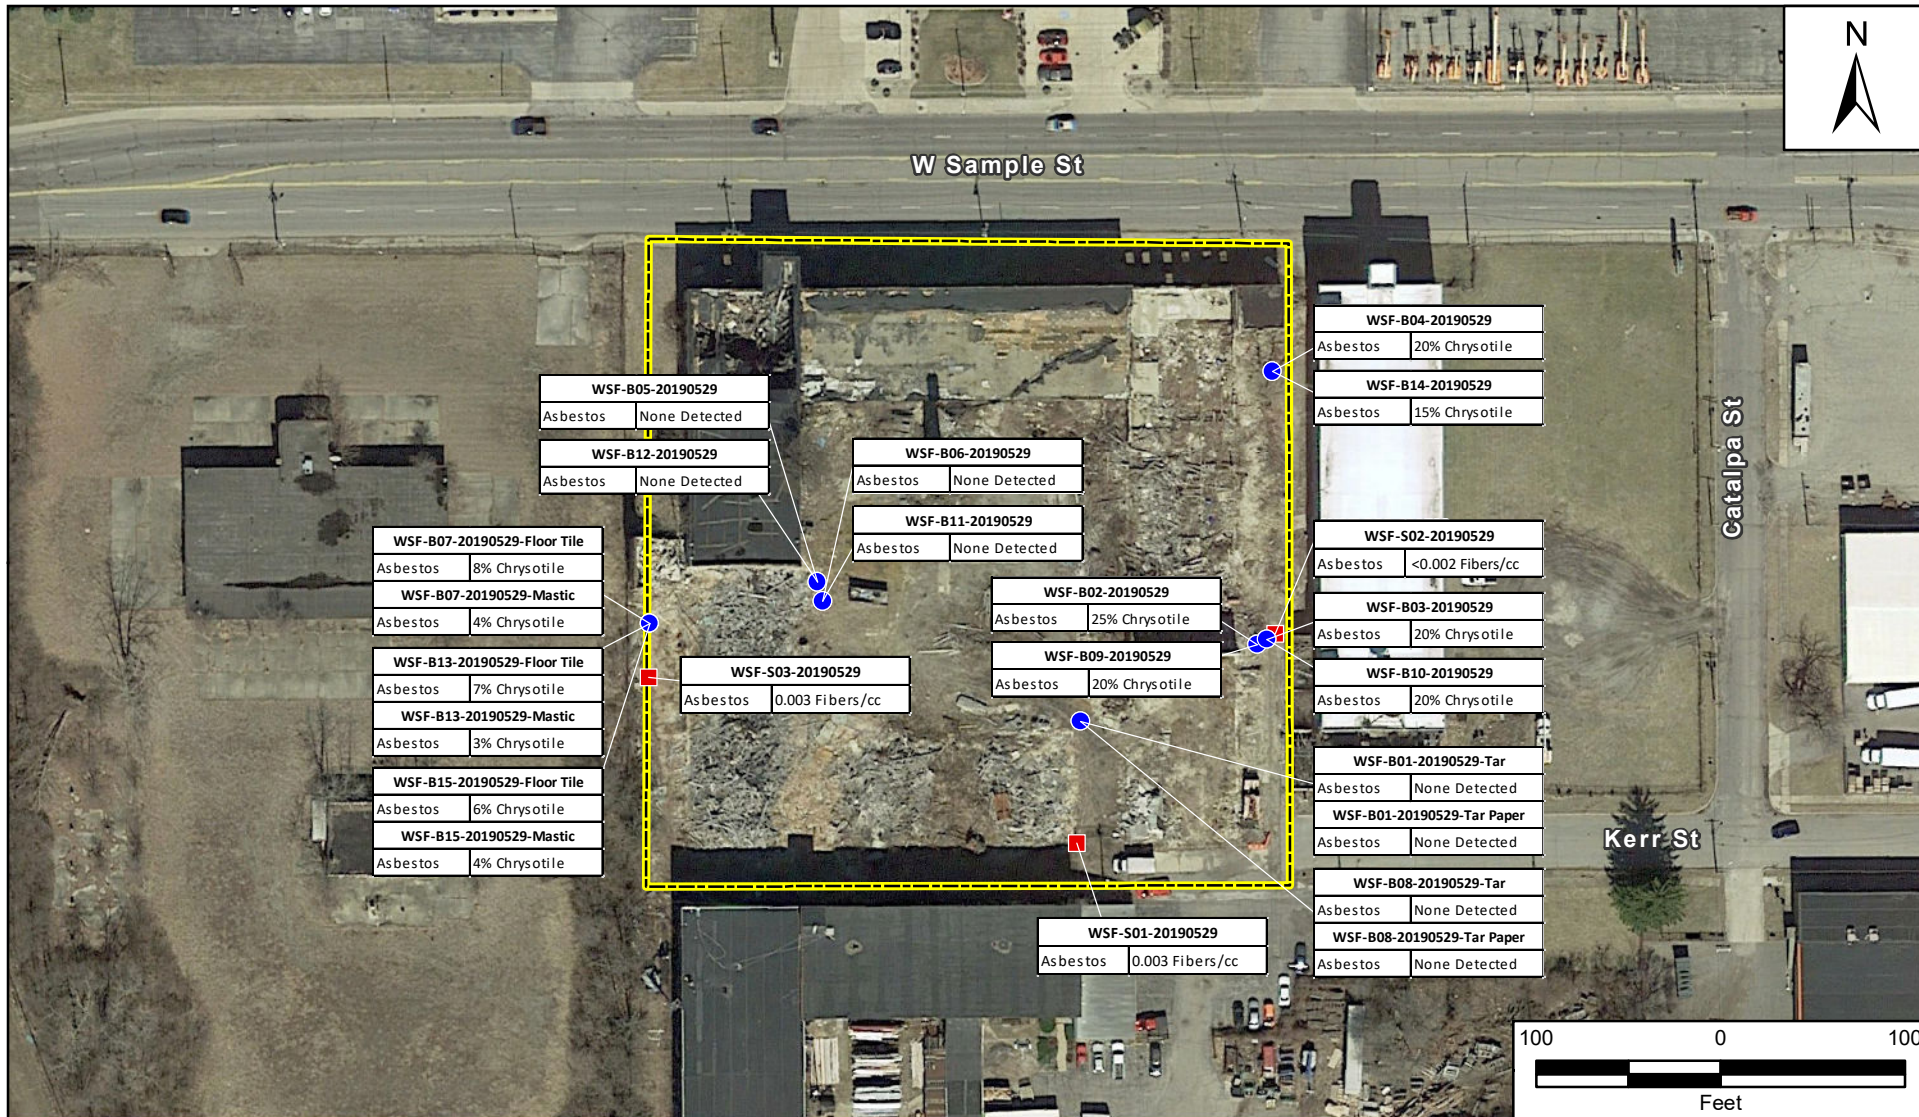
**Figure 3**  
**Asbestos Sample Results**

Tetra Tech START conducted perimeter air sampling at three stationary locations during site assessment activities to assess potential for exposure of adjacent businesses to fugitive asbestos fibers (see Figure 3 in Appendix A). Those sampling locations were at the eastern, southern, and western perimeters of the site. Sample collection proceeded by use of high-volume air sampling pumps fitted with 25-millimeter (mm), 0.8-micrometer ( $\mu\text{m}$ ) mixed cellulose ester (MCE) filter cassettes. Air samples were collected approximately 4 to 5 feet above the ground surface to represent exposures in the breathing zone. Filter cassettes were placed at an approximate 45-degree downward position with the inlet caps of the filter cassettes removed (open-faced) during sampling. Flow rates of the fully assembled air sampling trains were calibrated and recorded before and after sample collection by use of a Mesa Labs Defender 510 Drycal rotameter.
